### **Limited Visual Dam Safety Inspection Summary Report**

MA-073

Reservoir 24

May 2006

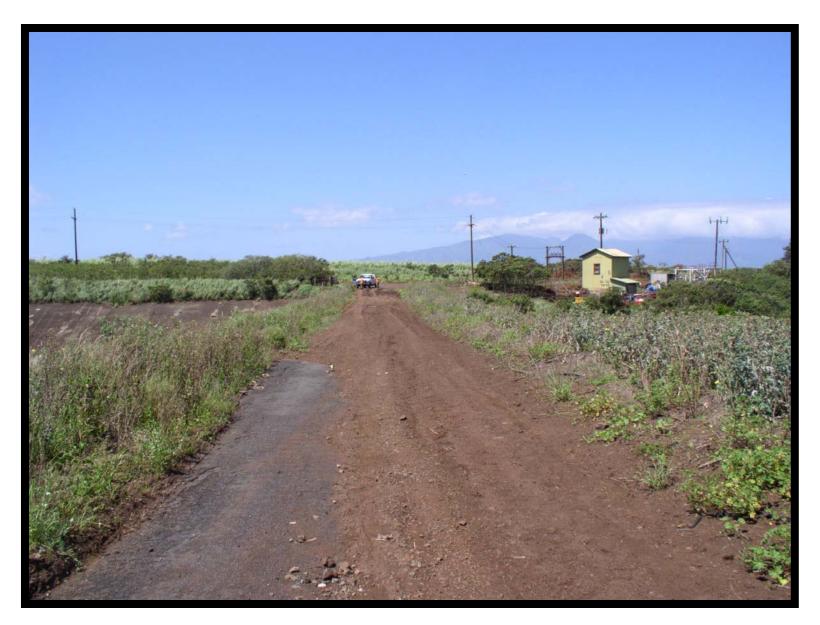
073 Crest

The dam crest was approximately 20 feet wide.

- a. The dam crest appeared to be in satisfactory condition, no corrective actions are required at this time.
- b. Access along the crest was satisfactory.

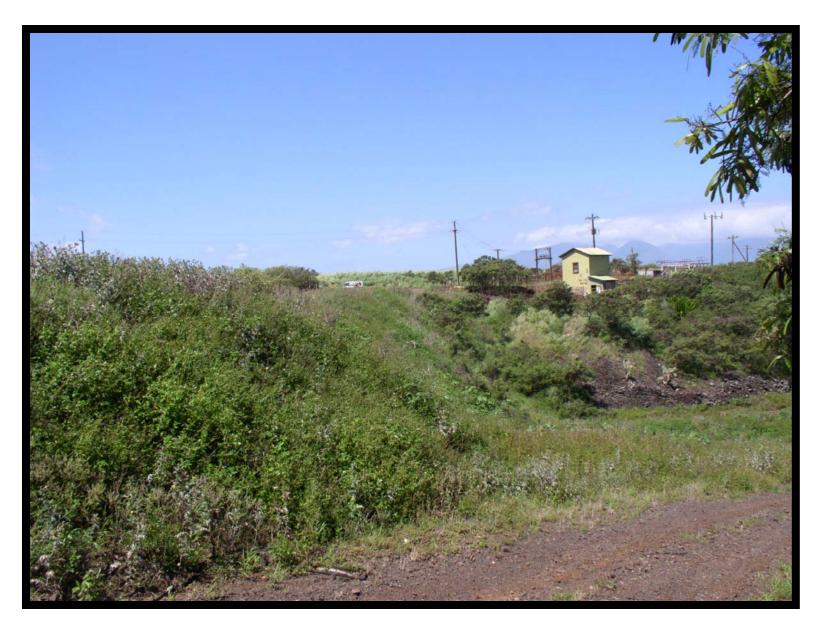
The downstream slope was approximately 1 on 1. Bushes and tall grass were growing on the downstream slope, obscuring it from visual inspection.

- a. The downstream slope appeared to be in fair to poor condition and requires corrective action.
- b. Slope protection needs maintenance. Need to remove tall vegetation from the downstream slope.
- c. The downstream slope was not visible due to high grass and bush vegetation. Clear high vegetation and maintain low to enable easy inspection.
- d. The slope was very steep, around a 1 on 1 slope. Further study is required to verify slope stability.

073 Downslope - Note the tall vegetation on the slope.

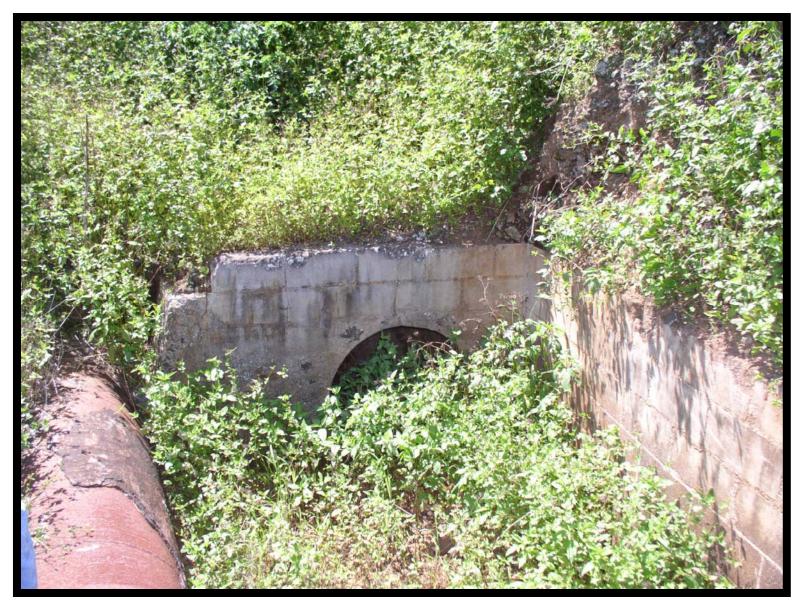
073 Outflow - View of the outlet pipe from the reservoir, looking upstream from below the dam. Note this outlet is partially silted in.

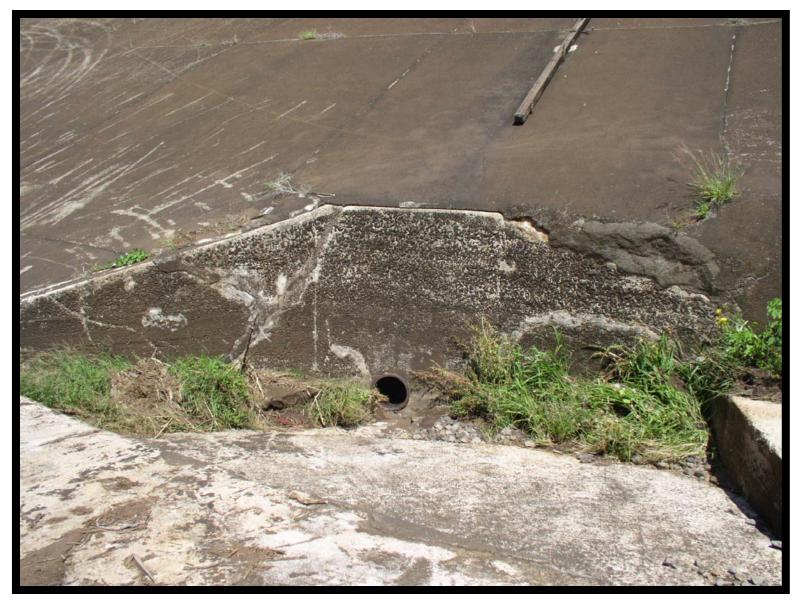
073 Outlet - View of the outlet from the reservoir looking from the reservoir.

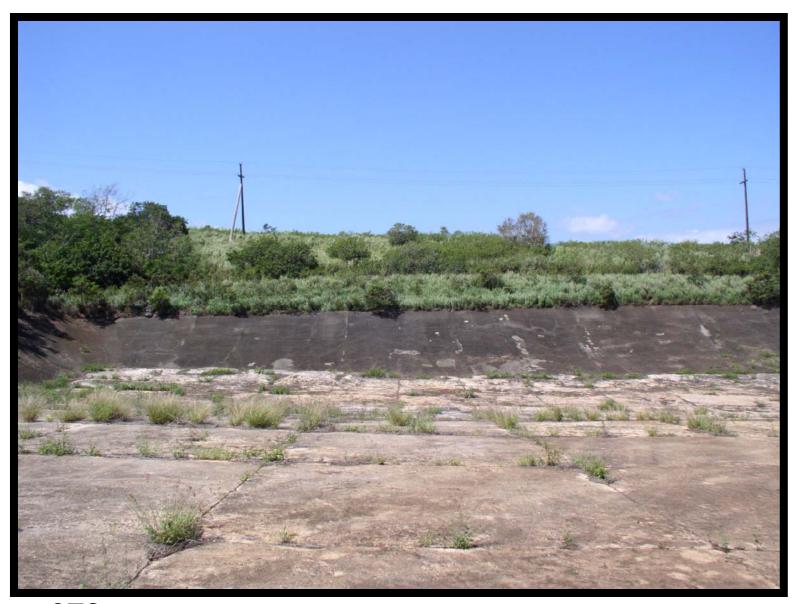
073 Pan 1 - Panoramic view of the reservoir, looking around the inner slope from the reservoir.

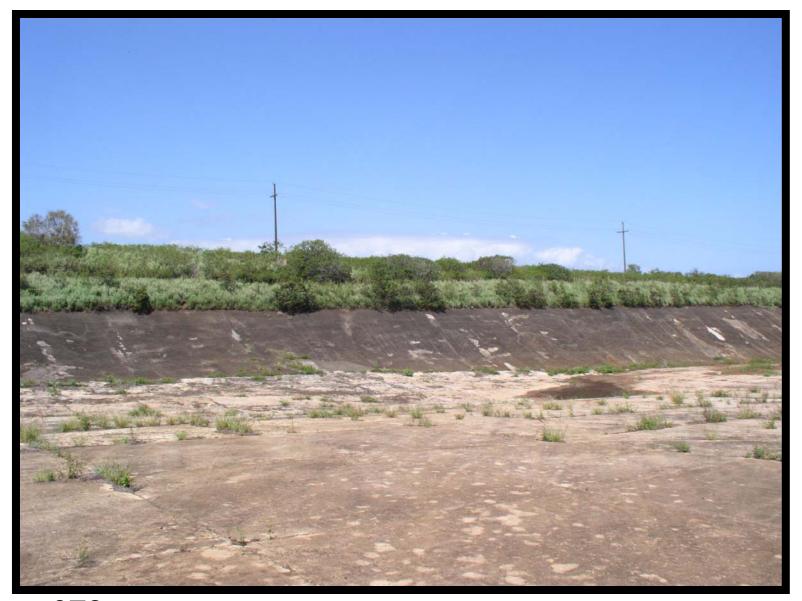
073 Pan 2 - Panoramic view of the reservoir, looking around the inner slope from the reservoir.

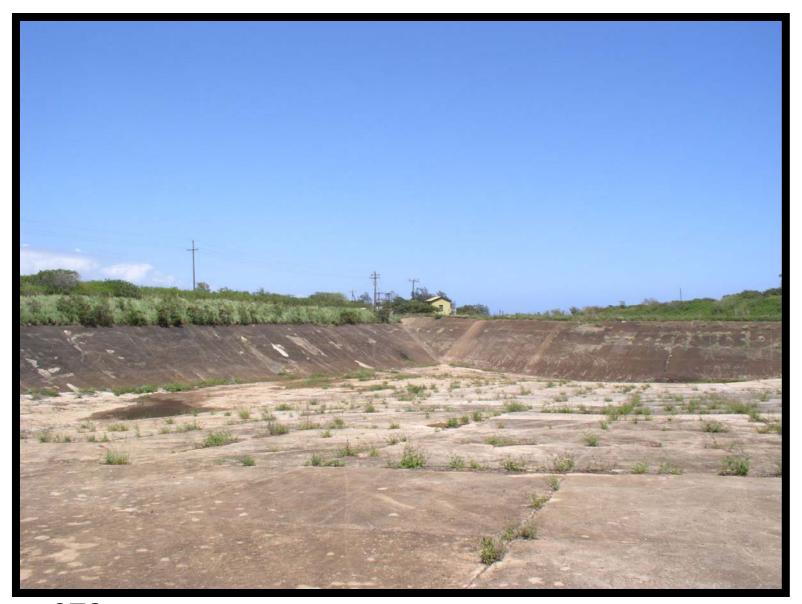
073 Pan 3 - Panoramic view of the reservoir, looking around the inner slope from the reservoir.

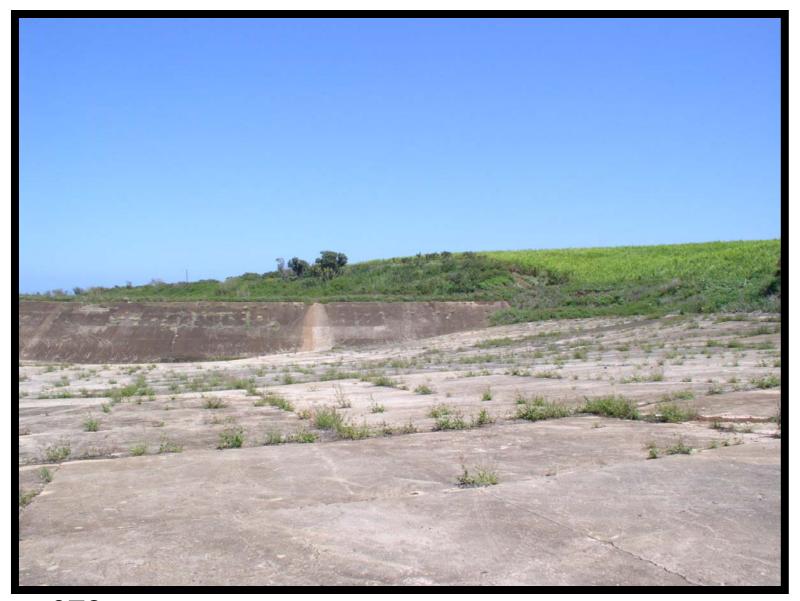
073 Pan 4 - Panoramic view of the reservoir, looking around the inner slope from the reservoir.

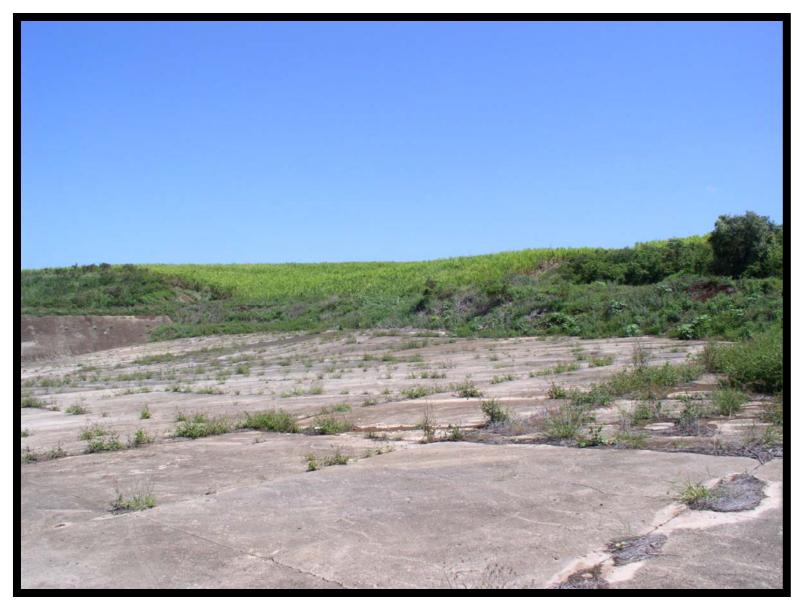
073 Pan 5 - Panoramic view of the reservoir, looking around the inner slope from the reservoir.

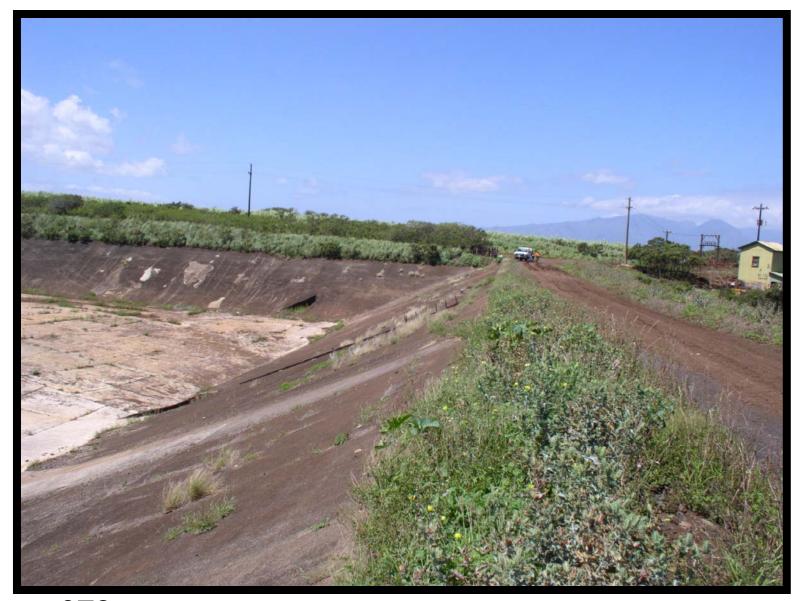
073 Upslope - Looking from downstream of the reservoir at the downstream slope

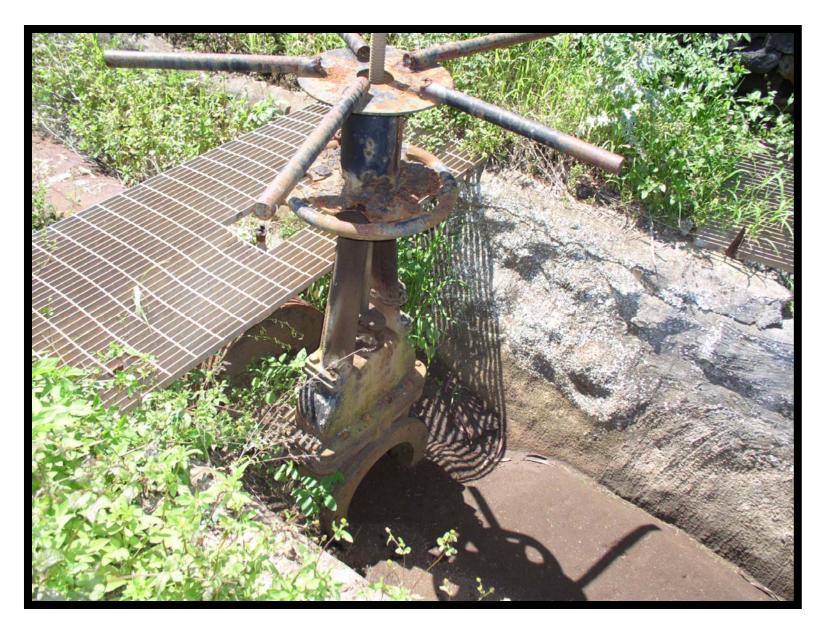
The outlet works consist of a 24-inch diameter DIP pipe controlled on the downstream side of the dam by a valve. The valve is left open.

- a. The outlet works were not tested.
- b. The outlet works appear to be in satisfactory condition. No corrective actions are required at this time.

073 Valve - outlet pipe and control valve
